Subject: Permit Issuance Status and Compliance Inspection Summary

CAFO WPDES Compliance Report (September 12, 2012)

Inspection date: September 7, 2012

Operation Name: Kane Family Farm

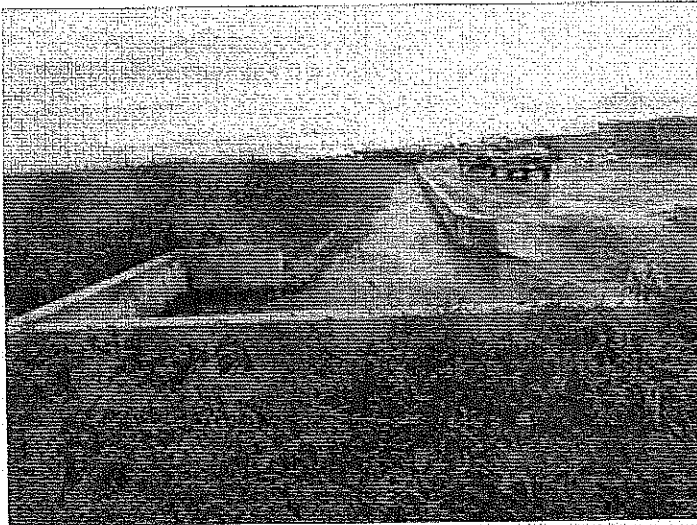
At the time of inspection, most of the feed was stored in bunkers on a concrete pad which drains to a tile inlet that drains to a 5,000 gallon tank and is then pumped to Waste Storage Facility (WSF) #3. After the first flush is collected (156,943 total gallons which is comprised of leachate and 0.05" rainfall as per the as built documentation), the remaining runoff disperses into a spreader box before flowing into the vegetated treatment area. At the time of inspection, Mr. Kane noted the stressed condition of the corn that is growing in the VTA. Alternative crops were suggested as an alternative to corn within the VTA; any alternative vegetation that is grown in the VTA shall be kept at a height that allows visual inspection for signs of erosion or excessive nutrient loading to the VTA. The floor and bunker walls appear to be in good condition; most of the construction has occurred within the last two years. Feed is typically put up at 63%-64% moisture which reduces the amount of leachate generated. Small amounts of feed appeared to be placed over the west side of the feed pad. Although there were no signs of leachate migrating from the feed, it is highly recommended that all feed be placed on the pad to promote drainage to the feed leachate collection system and reduce the potential for an offsite discharge.

Image 3: Image Direction: South
Leachate collection point, spreader box, and the VTA which extends to the east.

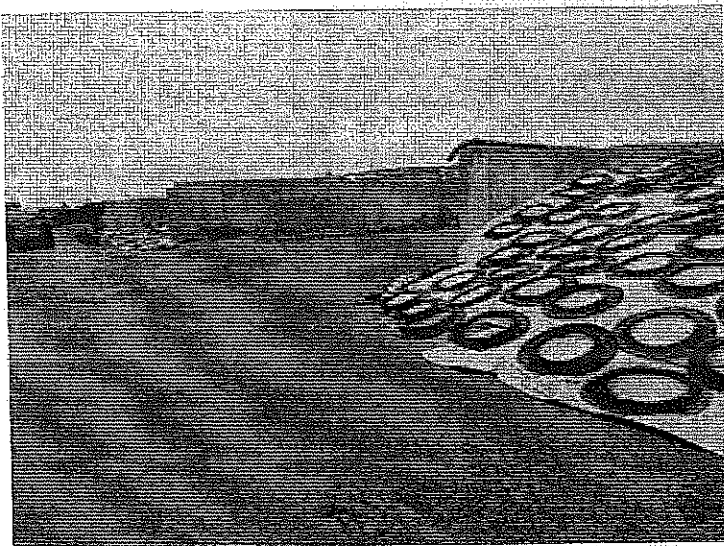
Image 4: Image Direction: Southwest
Feed leachate and runoff flows east and then north to the collection area shown in Image 2.

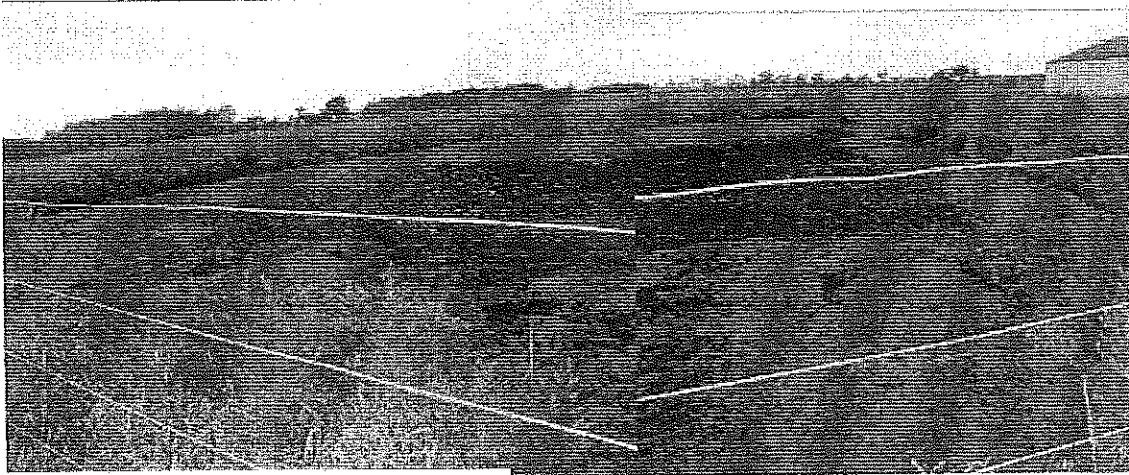
WSF #4 is a .5 million gallon clay-lined storage located at Cooperstown and is used primarily for the solid manure generated by the heifers kept onsite. At the time of inspection the facility had adequate freeboard and there was no evidence of overtopping. An MOL marker will need to be installed at this storage facility.

Image 6: Image Direction: North

WSF #4 was operating with adequate freeboard. Manure storage level markers (including MOL) must be installed.

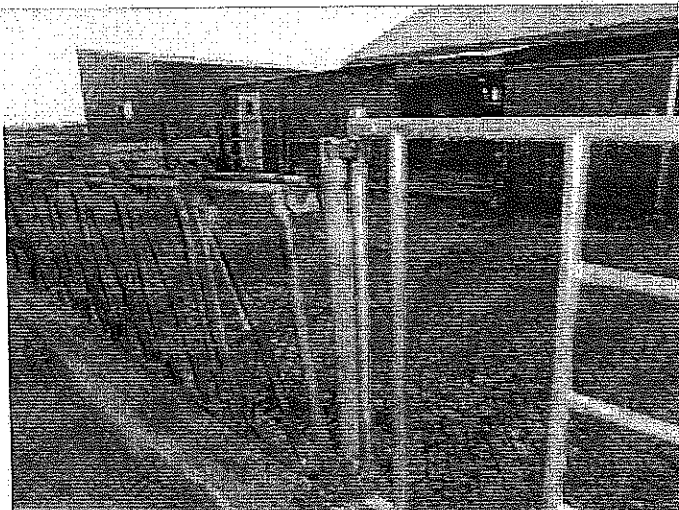
Image 7: Image Direction: Northwest
Outdoor feedlot at the Main Dairy. Lot is scraped 1-2 times per week; no offsite discharges were observed at the time of inspection.

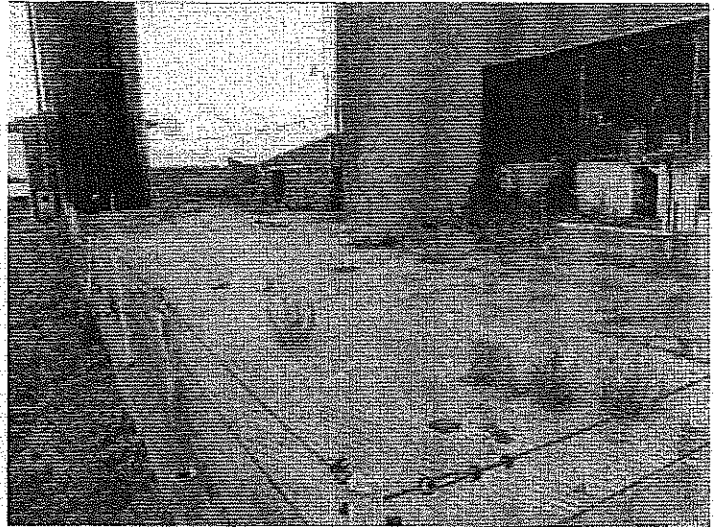
Image 8: Image Direction: West/Northwest
Outdoor lot/barnyard located southwest of the parlor.

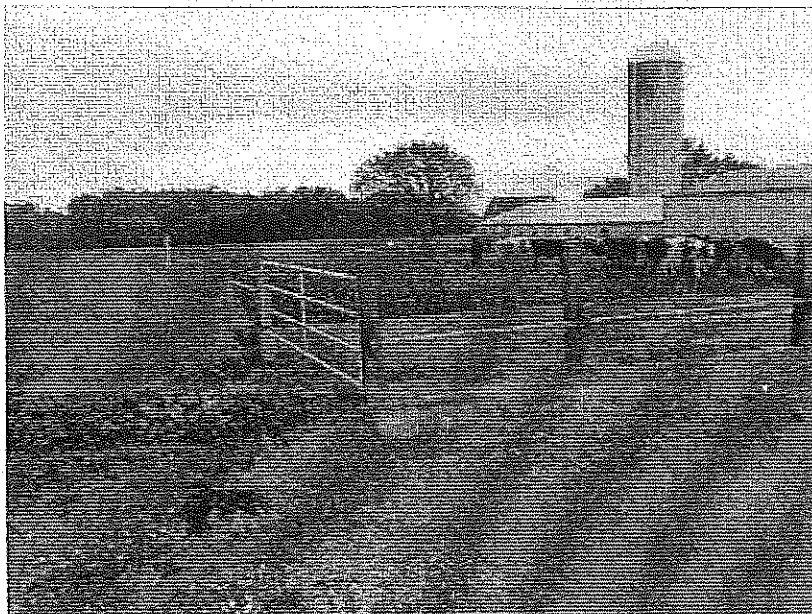
There are two outdoor lots at Cooperstown; each is approximately 18,000ft², one of which includes a 2,200 ft² paved drive by feeding area. Neither lot showed evidence of offsite discharges; areas adjacent to the lots were well vegetated and showed no signs of channelized flow. The lots were evaluated using the Barnyard Evaluation Rating Tool (BERT); neither lot was assumed to be a resource concern. The feedlot on the south side of the facility was clean at the time of inspection; however, the field south/southeast of the feedlot showed signs of stressed vegetation. This may or may not be related to the feedlot runoff. It was recommended to Mr. Kane by Ms. Gail Lisse, P.E. that drive-over curbs be installed at the gates to the feedlots to assist with keeping manure and contaminated runoff on the lot; the Department agrees with this recommendation. Mr. Kane stated that both of the concrete feedlots are cleaned daily and the material is placed into WSF #4. The outdoor exercise lots are scraped yearly and the material is placed on the dirt mounds that exist within the lots.

Image 9: Image Direction: East
The two outdoor lots are shown in this image; the lot with the paved feeding area is seen in the foreground and the second lot exists east of the fence that divides the two lots.

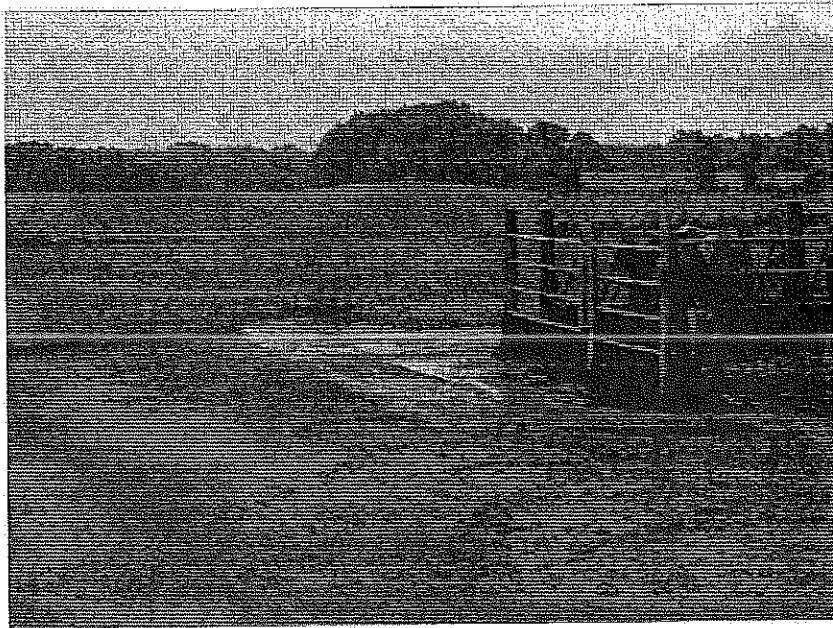
Image 10: Image Direction: South
Feedlot on south side of
Cooperstown. At the time of
inspection, it appeared as though
waste material from the feedlot
may be reaching the field south of
the feedlot. A drive-over curb may
help contain any accumulated
manure to the lot.

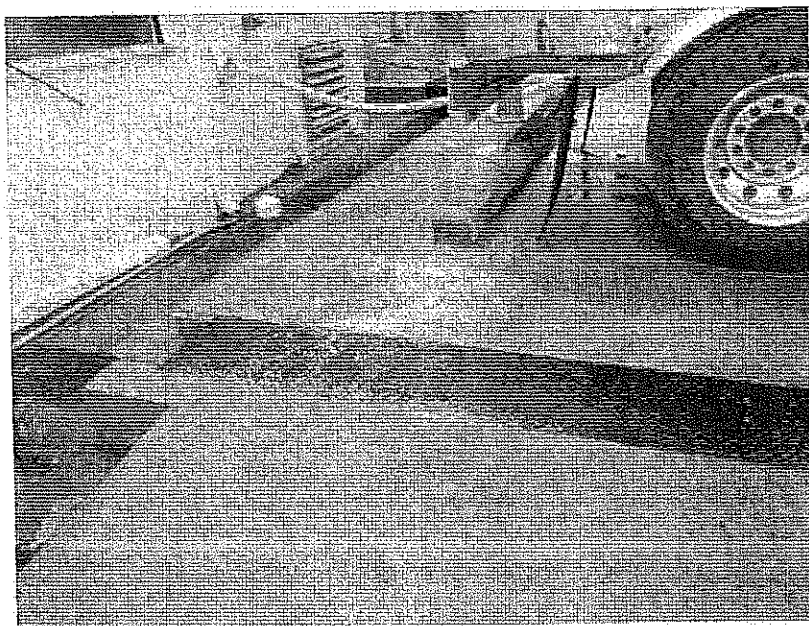
During the inspection spilled milk was noticed on the loading dock where the milk tankers were parked. This material enters a concrete collection channel and enters a small ditch before entering a filter strip that was designed by Brown County LCD to treat the contaminated runoff from the barnyard when it was in service. The material flows through the filter strip and continues west approximately to the west border of the temporary feed stack (Image 1). No evidence of further migration was witnessed; however, given the environmental impacts of milk house waste, it is important that measures are put in place to ensure that this issue is appropriately addressed and that the potential for an offsite discharge stops.

Image 11: Image Direction:
East
Spilled milk travels through a
concrete channel to a filter strip
prior to entering a field.

- The actions that will be taken and any practices that will be installed to address the milk-house discharge that is entering the filter strip.
- Plans regarding the installation of permanent markers for all liquid manure storage facilities.

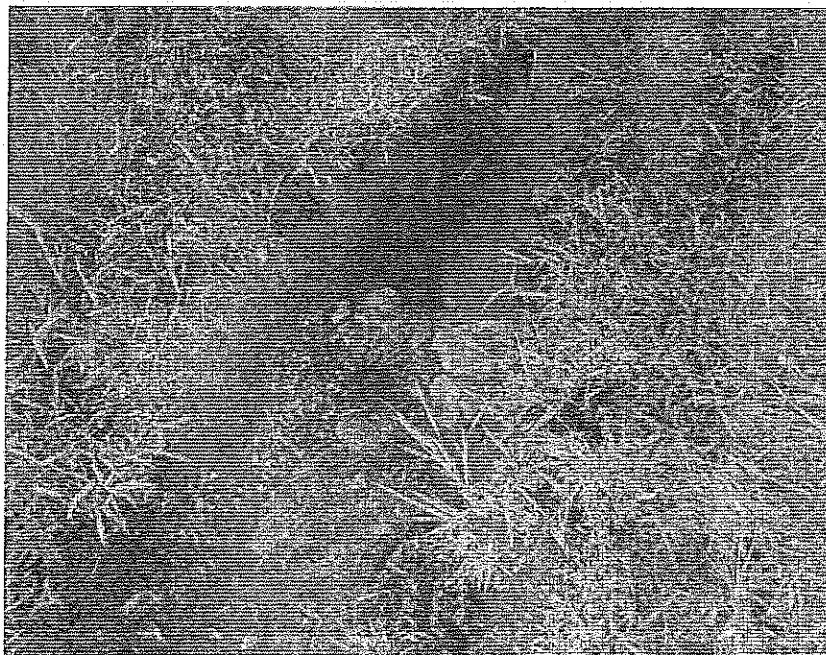
Image 12: Image Direction: N/A.
The contents of the ditch indicate that the milk discharge is likely a reoccurring issue.

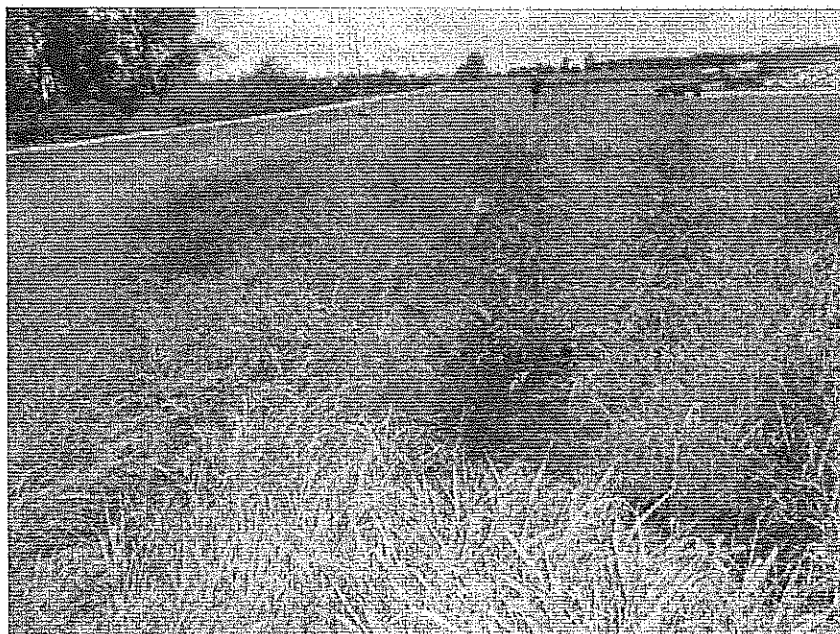
Image 13: Image Direction: West
Evidence of the milk waste discharge was observed as far as the western limits of the temporary feed pile that is seen on the upper right of the image. Migration distance is also shown by a solid blue vertical line in Image 1.
